Fukushima Nuclear Disaster

Updated January 18, 2012

Congressional Research Service

R41694

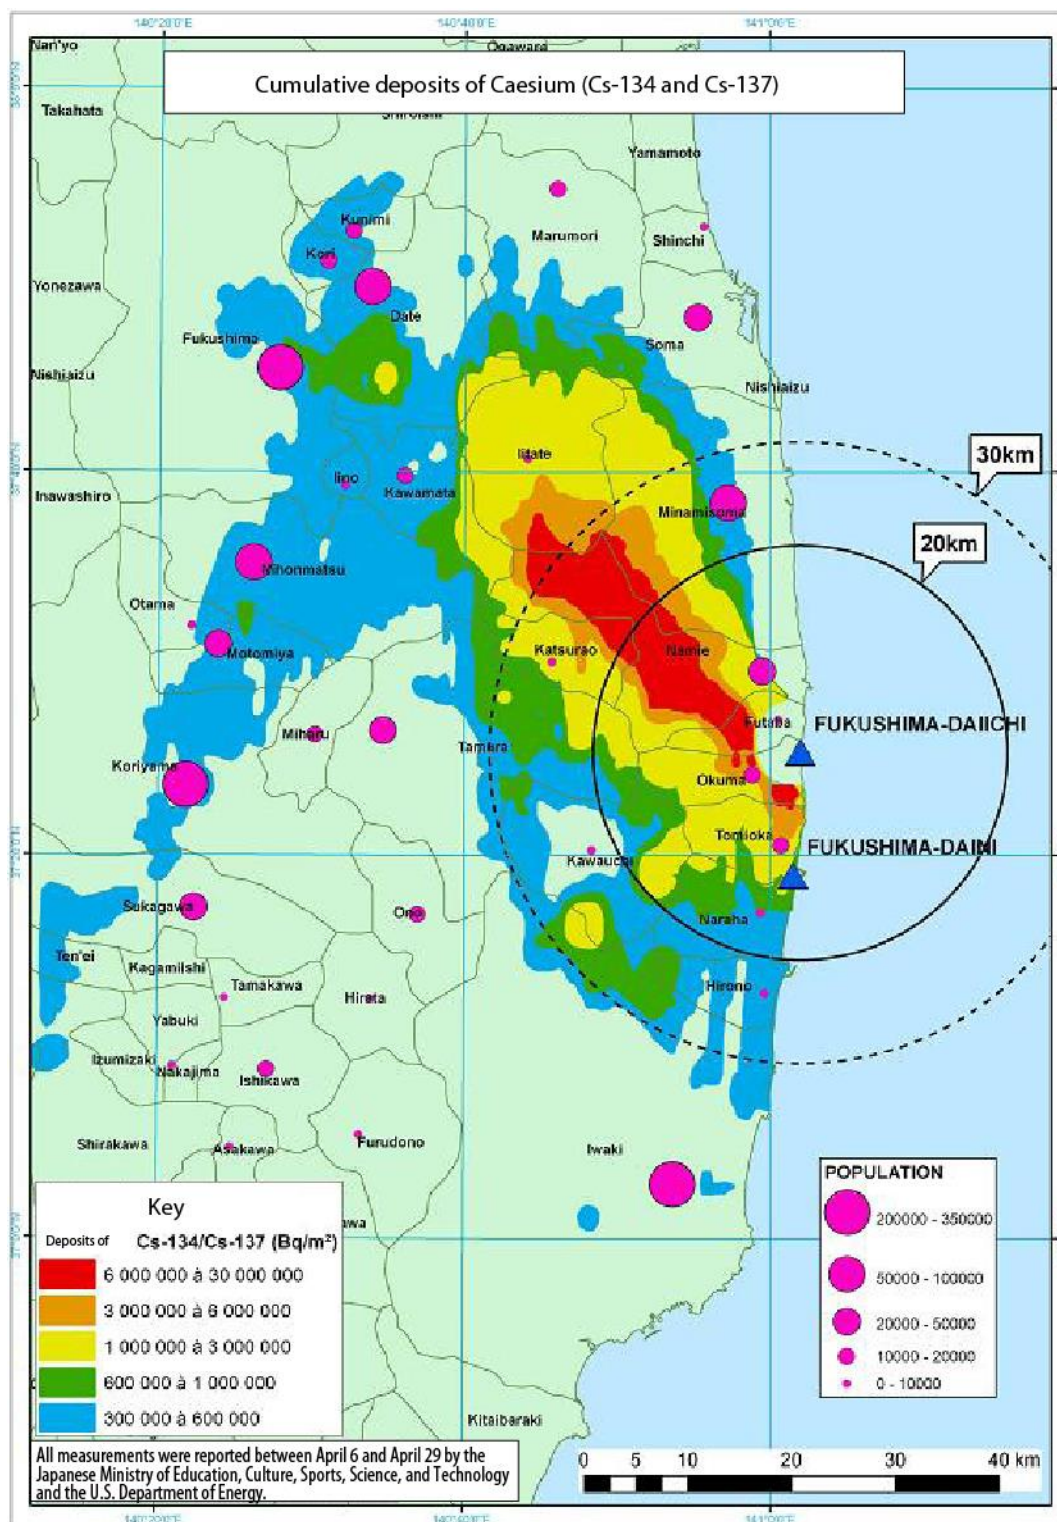
Figure 3. Cesium Depositions Around Fukushima-Daiichi

Note: 1 becquerel (Bq) = 27 picocuries (pCi)

Contamination of the land around the Fukushima plant was concentrated to the northwest, leaving large areas uninhabitable, as shown in **Figure 3**. Most of that contamination occurred when prevailing winds that had been carrying the plant's atmospheric releases over the Pacific Ocean shifted to the northwest during two days in mid-March and heavy rains washed the radioactive material from the air.⁴⁰ The depositions of radioactive cesium (the primary long-term land contaminant) are "comparable with the most contaminated areas of Chernobyl, even beyond the initial 20 km-radius evacuation zone around the Fukushima plant," according to the French Institut de Radioprotection et de Surete Nucleaire (IRSN). However, the amount of land around Fukushima with cesium deposits greater than 600,000 becquerels (16.2 microcuries) per square meter was estimated to be "only 8.5% of that of Chernobyl."⁴¹
